PROPERTY CONDITION ASSESSMENT

Project Site:
Acton Town Hall Complex
35 H Road
Acton, Maine 04001

TRC Project No. 523573.0000

Report Date: May 26, 2023

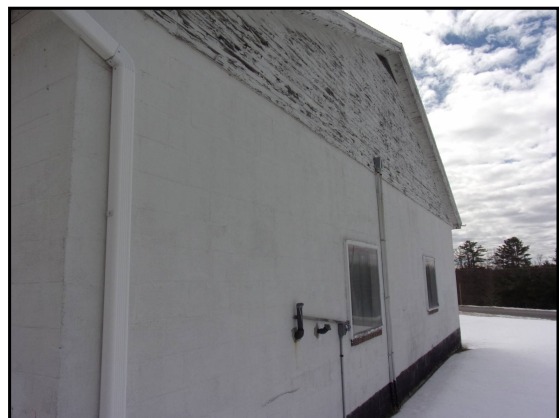
17: Step-down cracking in exterior CMU of Fire House

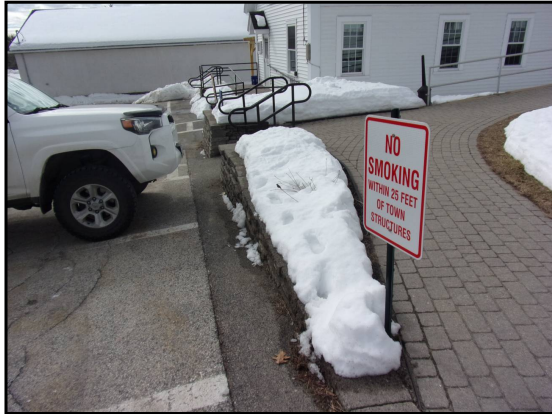
24: Distressed pavement / alligator cracking near Fire House

Recommendation: TRC recommends full-depth replacement of the asphalt paving sections throughout the property early during the term.

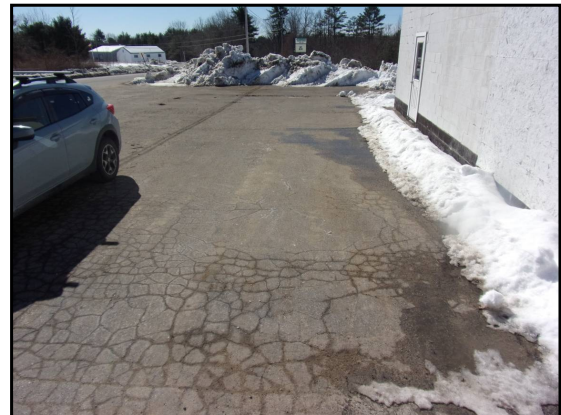
26: Large pothole near Fire House

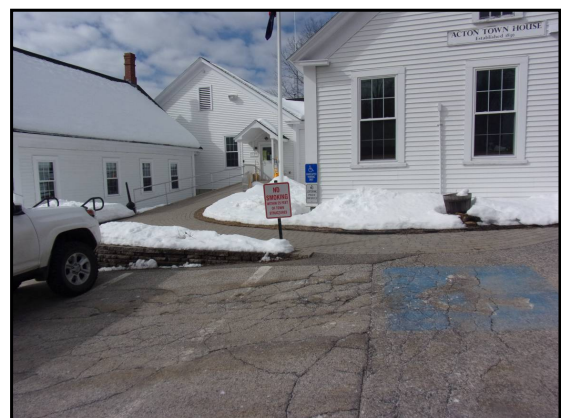
28: Pavement along north side of Fire House

Recommendation: Based on the reported runoff issues, TRC recommends installation of a French drain along the north side of the Fire House Building and parking area. This can be done during the time of asphalt pavement repairs. Costs for the French drain are included in the asphalt repair recommendations in Section 3.2.4 of this report.

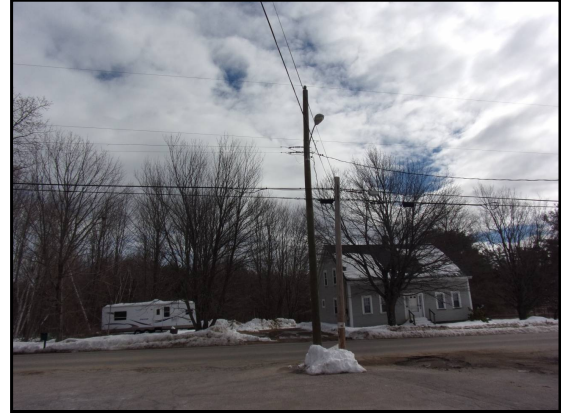
31: General asphalt condition

TRC recommends properly cleaning and continued seal coating and repainting of the pavement markings every 5-years following the recommended repairs to the asphalt.

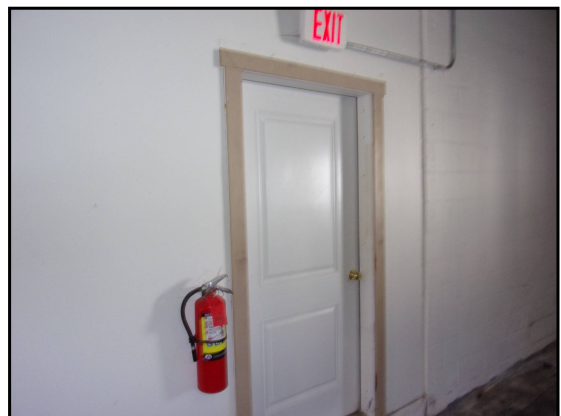
65: Typical wood framing element in Town Hall
