PROPERTY CONDITION ASSESSMENT

Project Site:
Acton Town Hall Complex
35 H Road
Acton, Maine 04001

TRC Project No. 523573.0000

Report Date: May 26, 2023

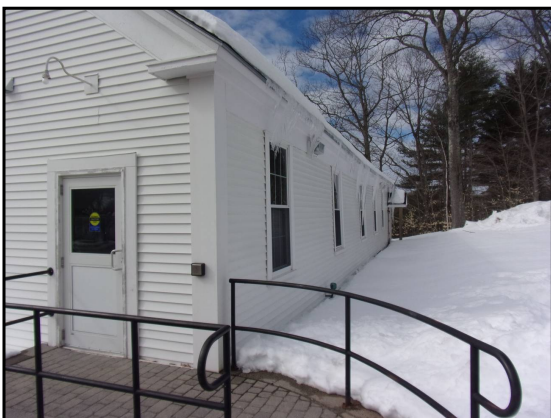
5: Entry ramp with pavers and metal handrails

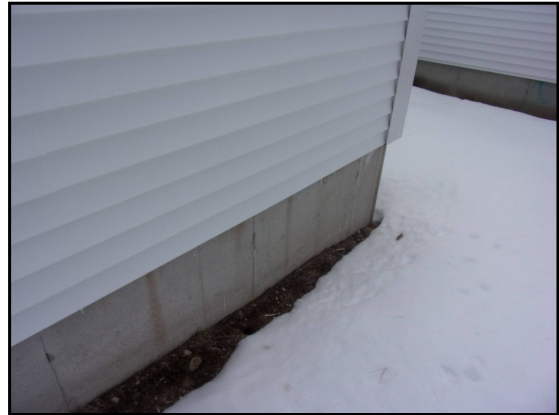
10: Foundation wall of Admin Offices

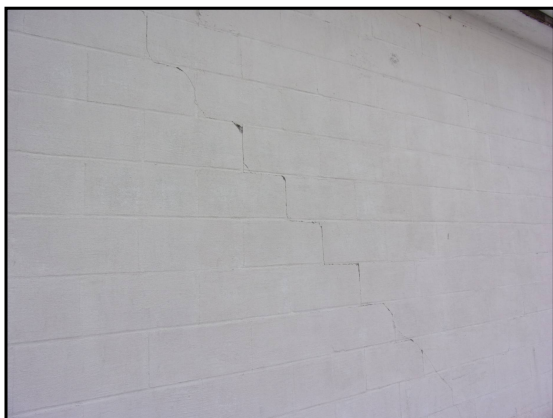
17: Step-down cracking in exterior CMU of Fire House

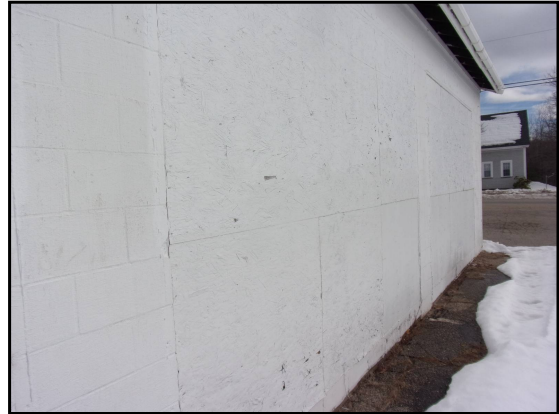
20: Boarded up truck bay

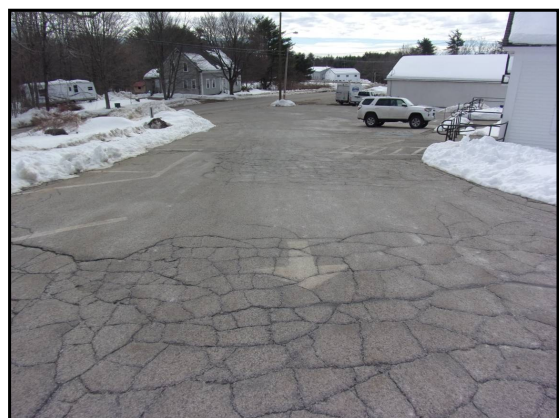
24: Distressed pavement / alligator cracking near Fire House

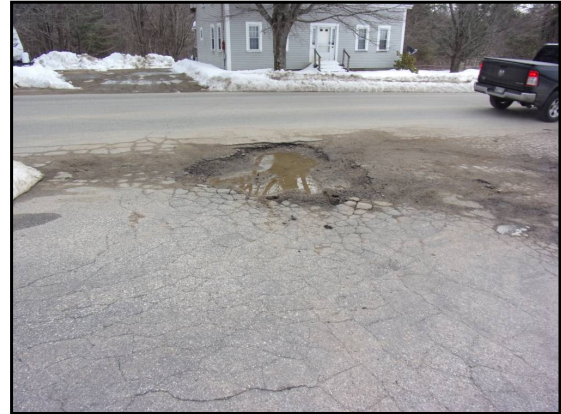
26: Large pothole near Fire House

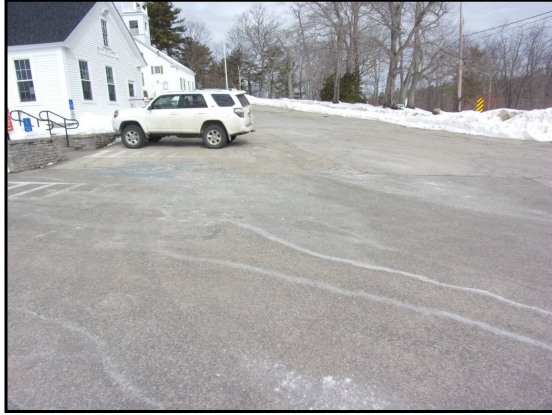
31: General asphalt condition

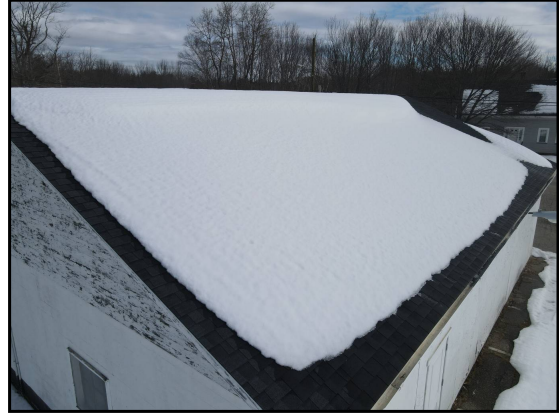
38: Fire House roof

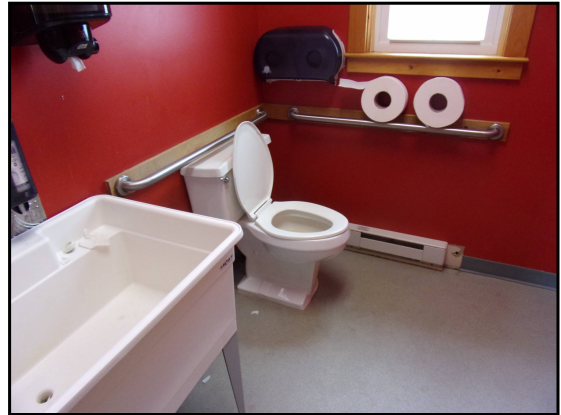
46: Public restroom in Admin Office / Town Hall

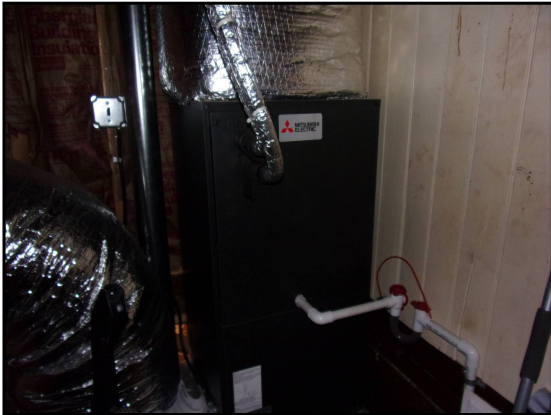
51: Interior HVAC in Town Hall

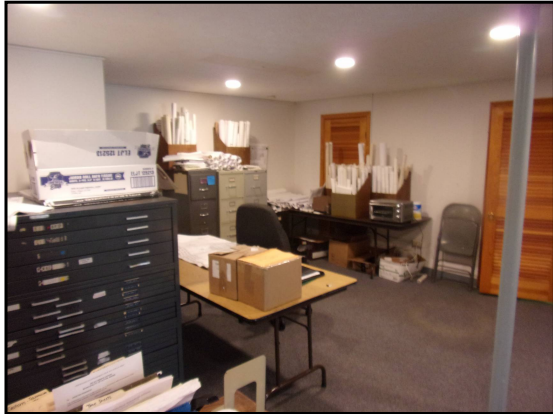
55: Basement in Admin Offices

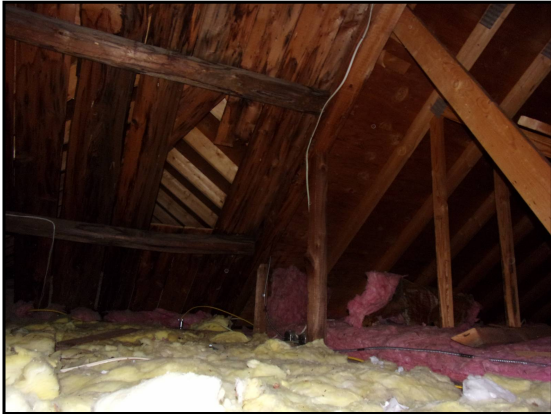
61: Attic area in Town Hall located under the connecting roof to Admin Offices

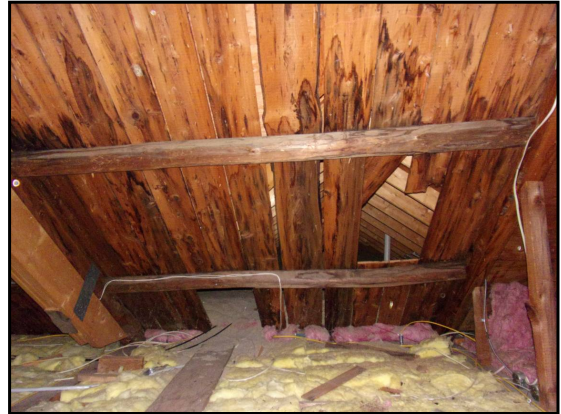
62: Opening in Town Hall roof to attic of connecting hallway

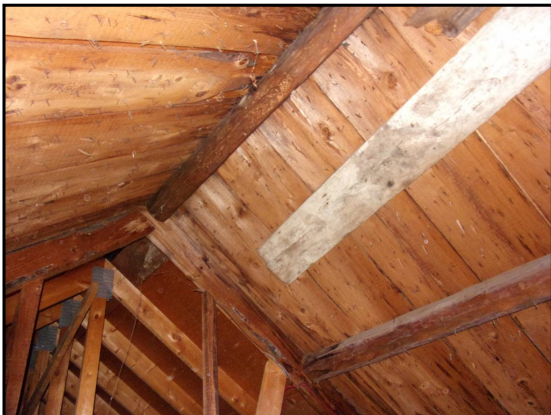
63: Town Hall roof decking and framing

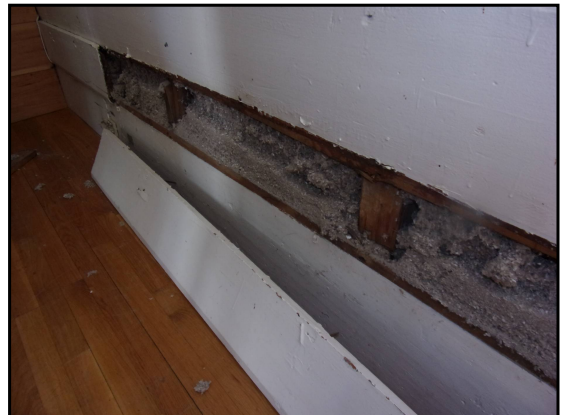
64: Exposed wood framing in Town Hall

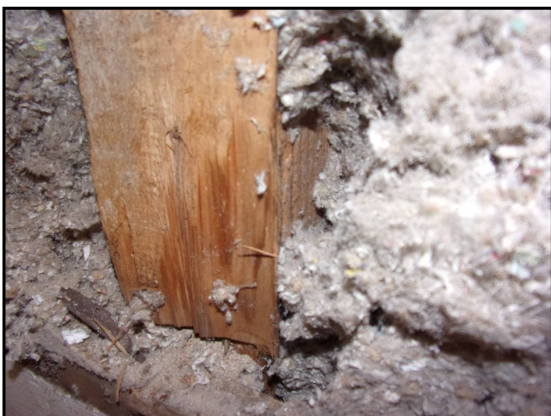
65: Typical wood framing element in Town Hall

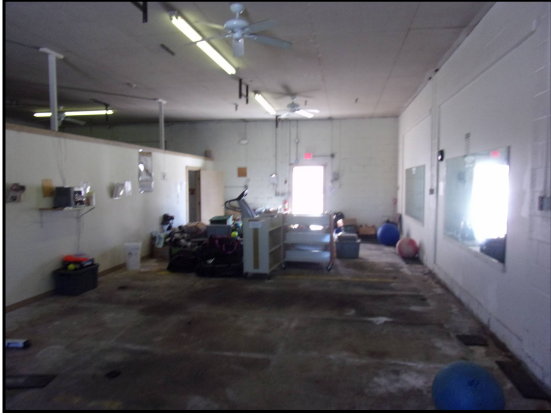
67: Interior of Fire House

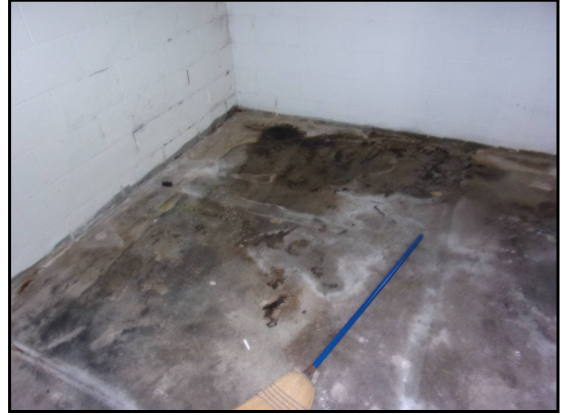
68: Fire House concrete floor slab

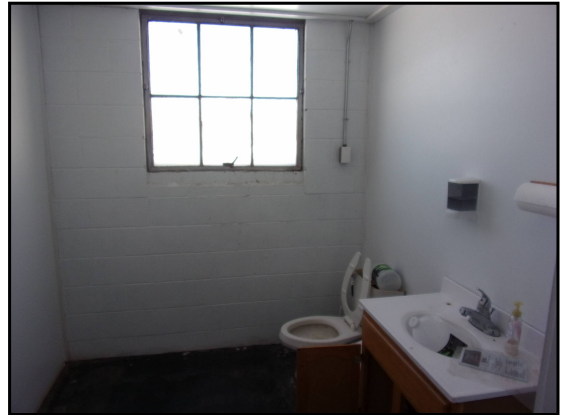
70: Restroom in Fire House

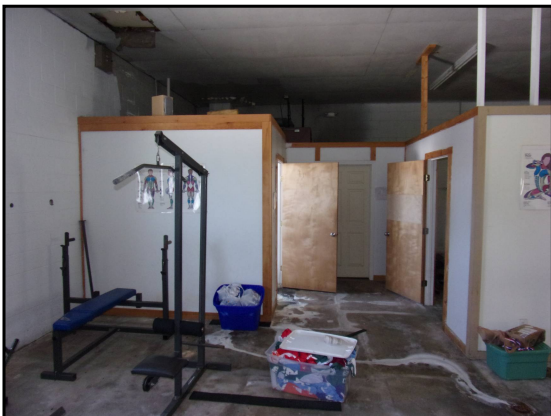
71: Fire House interior

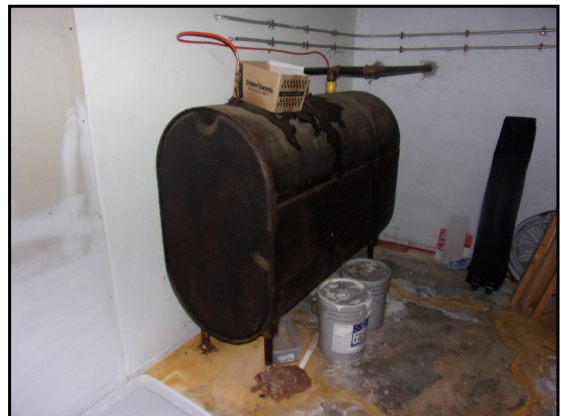
72: Fuel oil tank in Fire House

3.4.1 PLUMBING																			
Allowance for plumbing upgrades and/or repair	--	--	--	1	LS	\$20,000			\$20,000										\$20,000
3.4.2 HEATING, AIR CONDITIONING AND VENTILATION																			
Remove unit heater and fuel tank from Fire House	--	--	--	1	LS	\$5,000			\$5,000										\$5,000
Install two additional split system heat pumps in Town Hall Complex	--	--	--	2	EA	\$7,000			\$14,000										\$14,000
Install full HVAC system with distribution in Fire House	20	--	--	1	LS	\$20,000			\$20,000										\$20,000
Install radiant floor heating in Fire House	30	--	--	1	LS	\$8,000			\$8,000										\$8,000

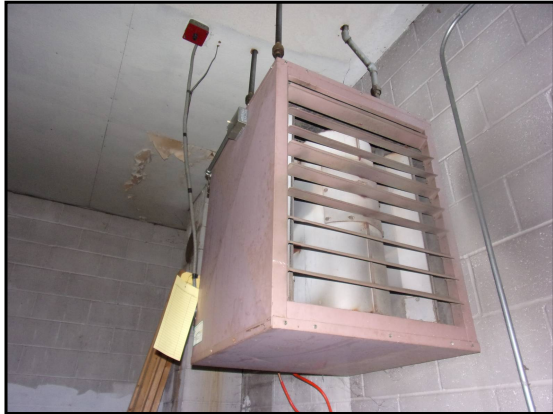
73: Space heater in Fire House

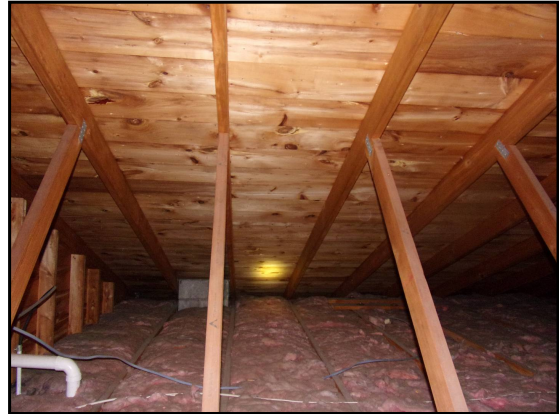
74: Fire House attic

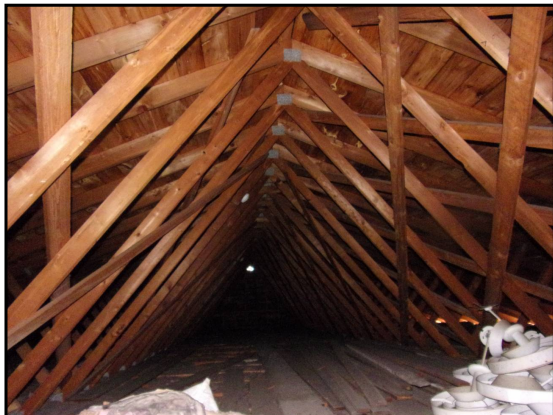
75: Fire House attic

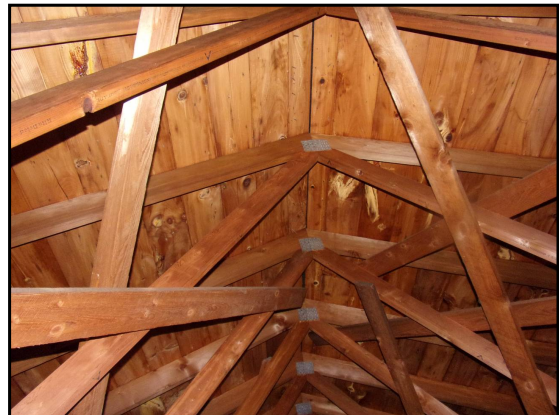
76: Fire House attic framing and roof deck

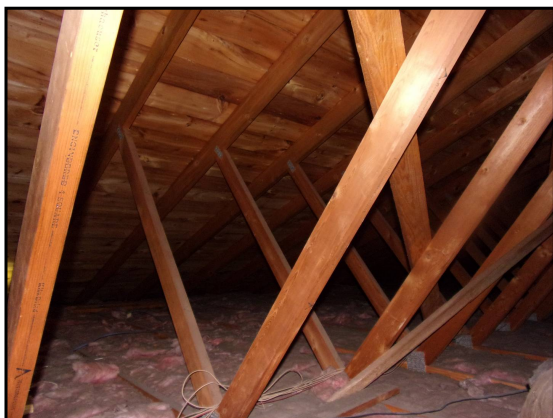
77: Fire House attic framing

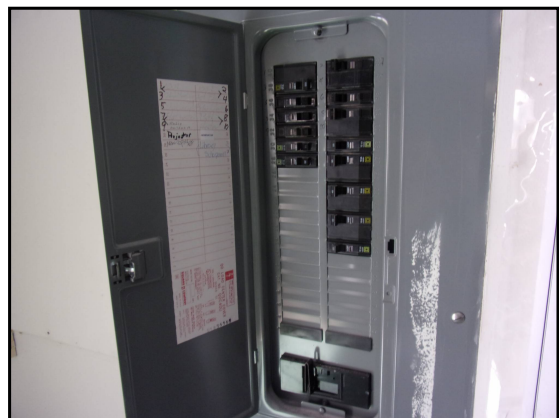
78: Typical breaker panel

3.4.3 ELECTRICAL																			
Allowance to replace and upgrade lighting fixtures throughout the facility.	--	--	--	1	LS	\$25,000			\$25,000										\$25,000
Allowance to upgrade electrical connections in Fire House and elsewhere as needed	30	30	0	1	LS	\$15,000			\$15,000										\$15,000
