PROPERTY CONDITION ASSESSMENT

Project Site:
Acton Town Hall Complex
35 H Road
Acton, Maine 04001

TRC Project No. 523573.0000

Report Date: May 26, 2023

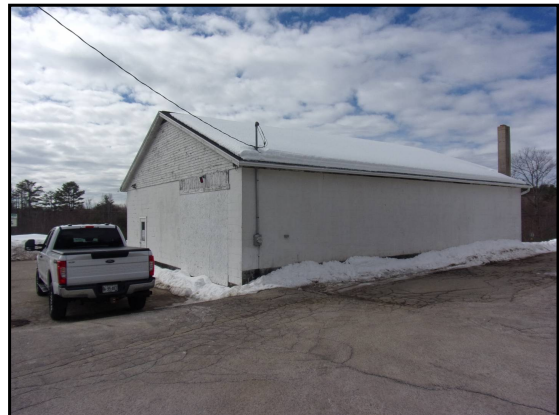
16: Former Fire House

For the Fire House, TRC recommends that all interior equipment, furniture, and interior walls be removed from the building. The ceiling panels and insulation above the ceiling should also be removed and disposed - leaving the wood framing, roof deck, and roof supports in place. During this time, the exterior cracks in the CMU walls (discussed in Section 3.3.2 of this report) should be sealed (tuck-pointed). Once the interior is clear of debris, the exposed concrete floor slab and CMU wall interior surfaces should be **thoroughly pressure washed with detergent**. TRC then recommends installing new wall and ceiling finishes and new exterior vinyl siding to match the other buildings at the property. For the boarded-up truck bays, TRC recommends installing large custom window systems to provide significant natural light within the building. Once the major renovations are completed, the Fire House Building may be used as the future Acton Town Library with the current Library Building utilized for the needed additional office space.

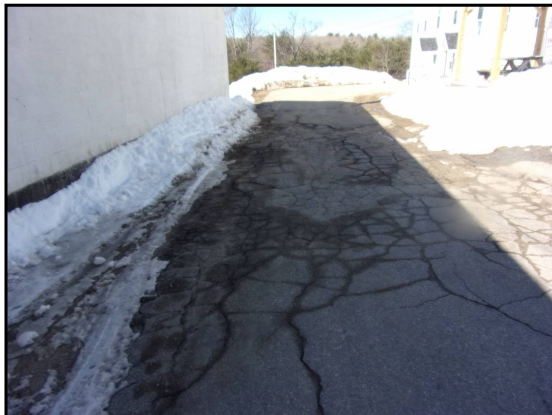
27: Pavement near Fire House

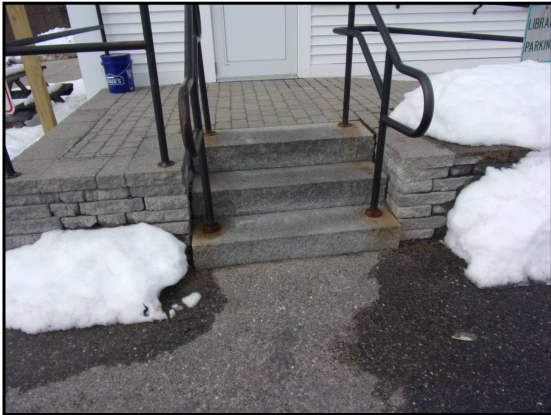
45: Steps to Town Hall

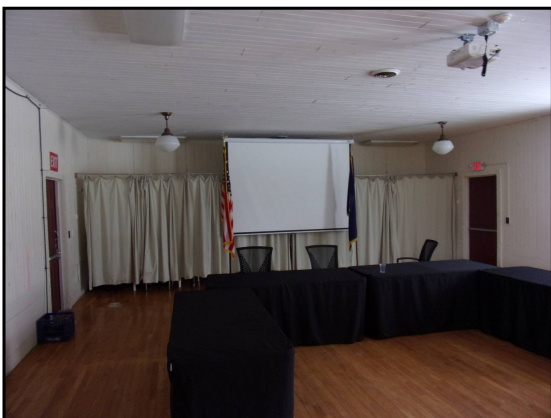
47: Town Hall interior

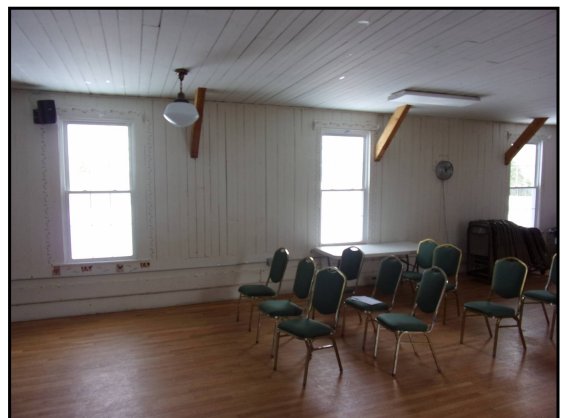
48: Town Hall interior

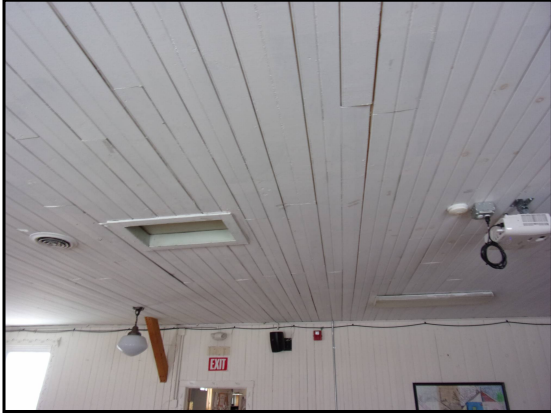
49: Town Hall ceiling finishes

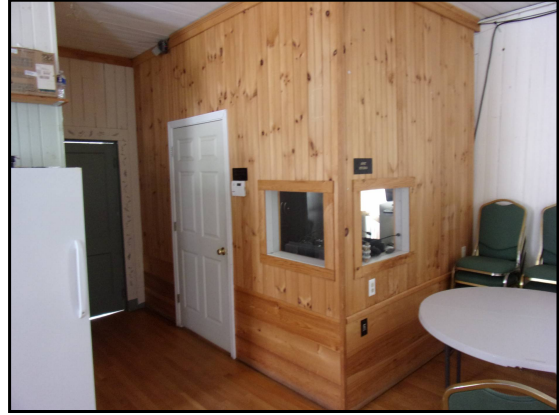
50: Video room in Town Hall

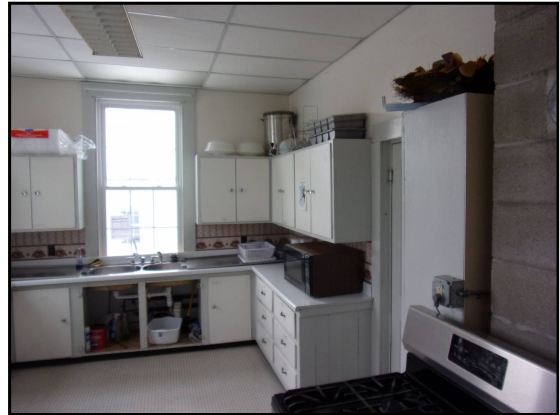
52: Town Hall kitchen area

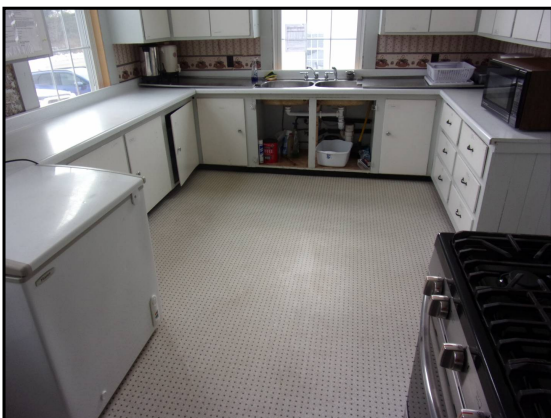
53: Kitchen floor finishes

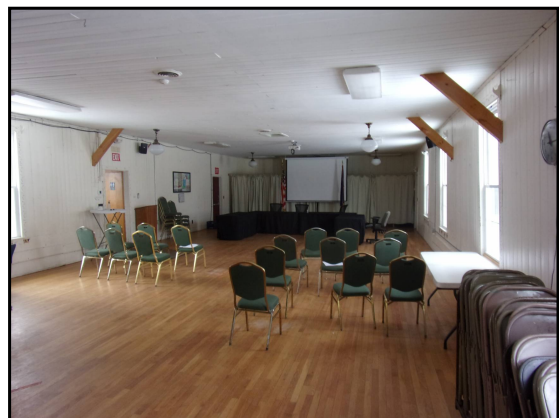
54: Town Hall floor finishes

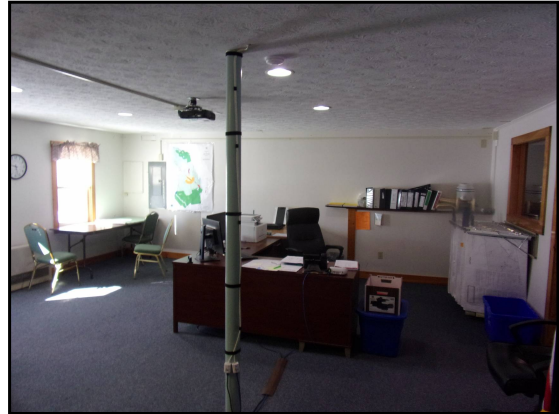
56: Basement

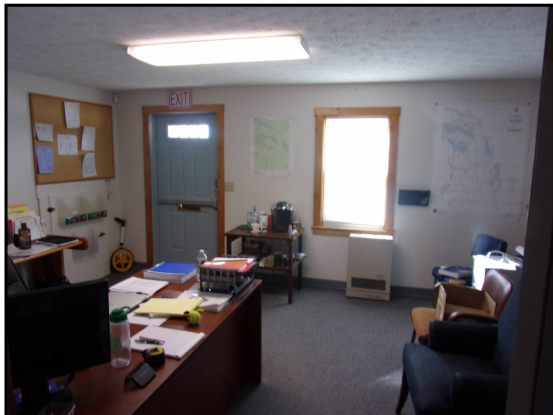
57: Basement office

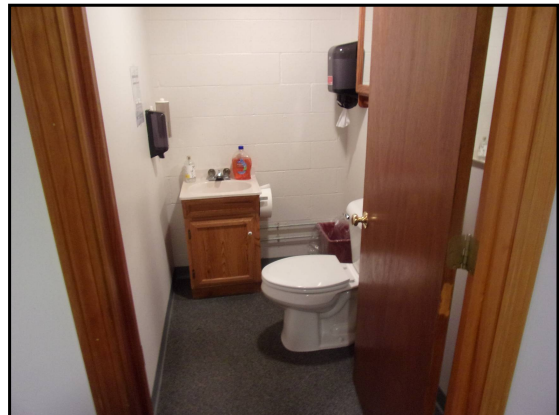
58: Basement restroom

3.7.2 TENANT SPACES																					
Re-locate library contents to new space	--	--	--	1	LS	\$5,000		\$5,000													
Build-out / renovate library space for new offices	--	--	--	1	LS	\$50,000			\$50,000											\$50,000	
Renovate basement restroom and add employee restroom at main level	--	--	--	1	LS	\$50,000			\$50,000											\$50,000	
Allowance for furniture, fixtures, and equipment	--	--	--	1	LS	\$30,000			\$30,000											\$30,000	
Total Immediate Repair Needs							\$8,000														
Total Short Term Repair Needs								\$128,840													
AVE. EUL - Average Expected Useful Life	Total Estimated Costs, Uninflated						-	-	\$566,870	-	-	-	\$3,000	-	-	-	\$3,000	\$3,000	\$575,870		
EFF. AGE - Effective Age (Estimated)	Inflation Factor at 2.50%						-	-	1.000	1.025	1.051	1.077	1.104	1.131	1.160	1.189	1.218	1.249			
RUL - Remaining Useful Life (Estimated)	Total Estimated Costs, Inflated						-	-	\$566,870	-	-	-	\$3,311	-	-	-	\$3,655	\$3,747	\$577,583

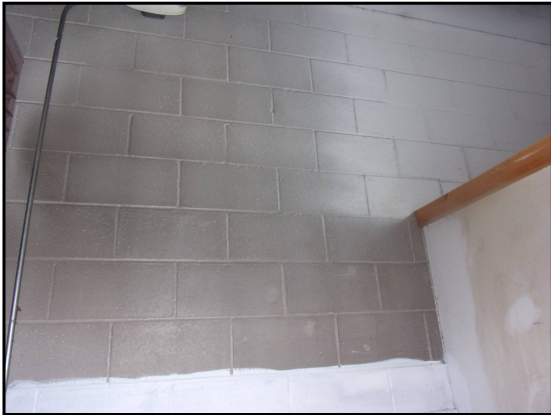
69: Interior CMU in Fire House
